SHORELINE CHANGE ALONG BUFFALO BAYOU: A GIS-BASED ASSESSMENT OF PROPOSED BULKHEAD IMPROVEMENTS TO ARCHEOLOGICAL DEPOSITS AT THE SAN JACINTO BATTLEGROUND STATE HISTORIC SITE, HARRIS COUNTY, TEXAS

Technical Report No. 87

AmaTerra Environmental, Inc.

May 2014

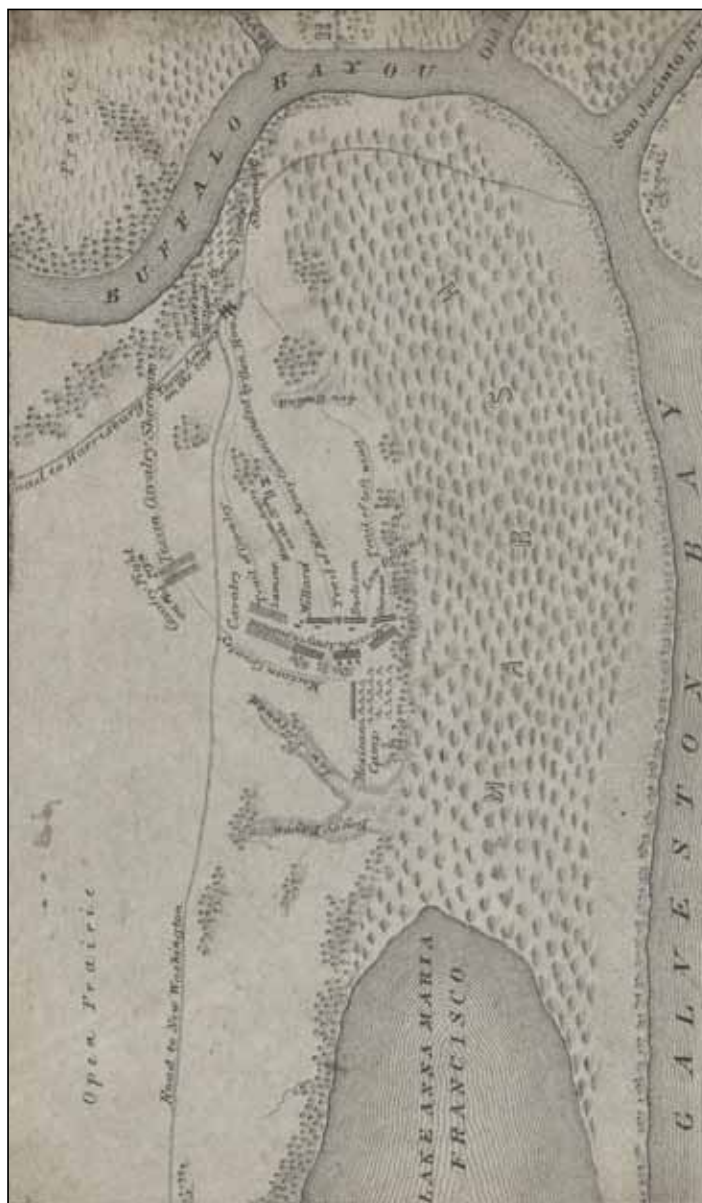
Figure 2.1. 1856 Yoakum Map of the San Jacinto Battleground.

On April 19, 1836, General Sam Houston and his army arrived on a small promontory landform along Buffalo Bayou, which extends out to the northeast towards Lynchburg, Texas. According to veteran accounts, the Texan army camped within a grove of timber situated along the banks of the Buffalo Bayou (Labadie 1967; **Figure 2.1**). More specifically, the camp was located “about two or three feet above the water's edge and ran back from fifty to one hundred yards on a level plain, covered with trees, but with little or no undergrowth, to a second bank about ten feet high” (Swisher 1932: 40). Today, the second bank is no longer evident (EDAW 2005). In a letter dated January 19, 1891, Ricardo de Zavala wrote that “the distances from Houston[']s camp [to] the Soldier[']s Graves is 155 steps which [is] supposed to be yards. From the Graves to where Houston formed lines of battle 450 steps from lines of battle to where the Mexicans were when they commenced [sic] firing [sic] (which is about the same as to

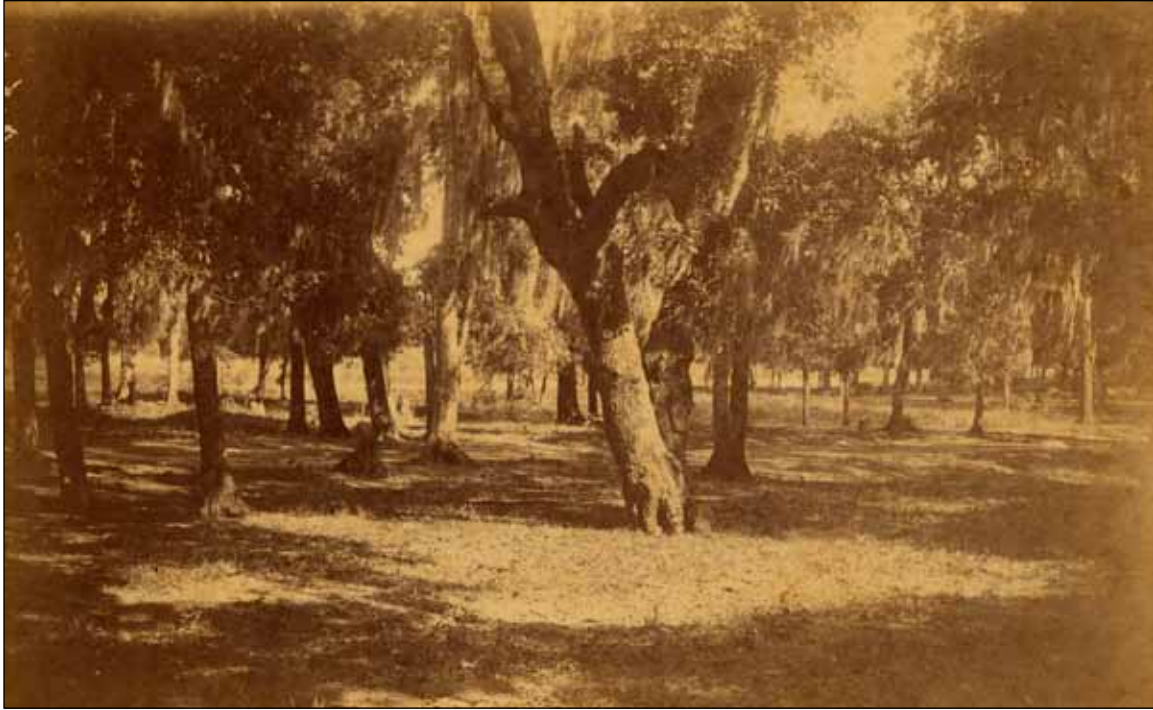
Figure 2.3. Undated photograph (ca. 1890s) of the grove wherein the Texan army camped and where Houston interviewed Gen. Santa Anna. A note on the back of it, dated 1939 indicates that the post-oak tree in the foreground is supposed to be the one Houston and Santa Anna sat under after the battle (*Photo courtesy of Herzstein Library*).

The War for Texan Independence concluded along Buffalo Bayou under a post oak tree (**Figure 2.3**) where Sam Houston extracted a general cease-fire from Santa Anna, who later officially surrendered, granting Texas its independence (DeWees 1968). In fact, veterans visiting the battleground on July 5, 1894, noted that "the famous tree was very near the water of the bayou on a level plat between the water's edge and the sharp decline of the bank or hill (Hill 1936:10)." Writing in 1936, Hill went on to say that, "the tree is thought to have rolled down and all trace of it has disappeared, but they fixed upon its location at a point near the bayou northwest from where the monument stands (Hill 1936:10)." From Hill's comments, it is not clear whether the actual tree was identified or not during the 1894 visit.

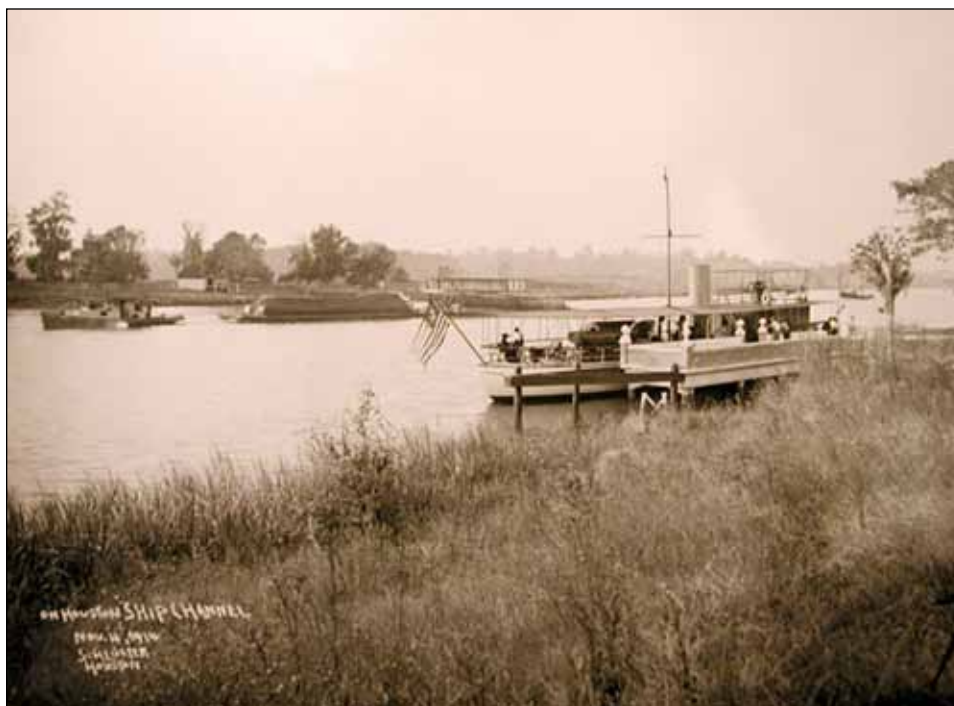
Figure 2.4. View of the Houston Ship Channel along Buffalo Bayou from the southern ferry landing in 1914. Note tugboats pulling barges near the opposite shore (*Photo courtesy of Herzstein Library*).

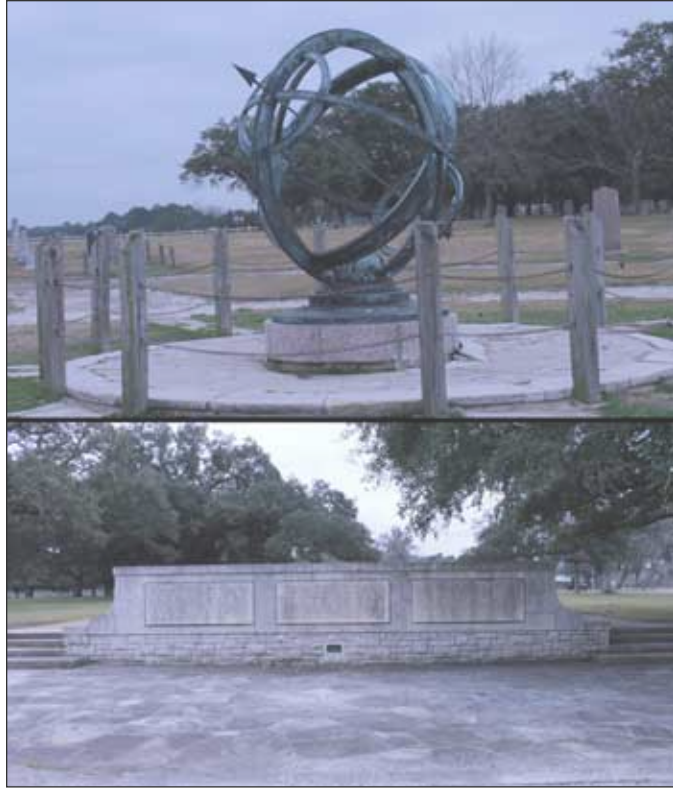
Figure 2.5 Landscape improvements and commemorative features within San Jacinto Battleground Site.

Prior to the battleground’s grand opening in 1910, two concrete landings, a crescent-shaped promenade along the water’s edge, an artesian well, iron gates, granite markers, and a driveway were installed throughout the site. Photographs suggest that over the next decade, the banks of the Buffalo Bayou within the site boundaries were graded. Additional structures erected post-1910 include two pavilions, a keeper’s lodge, a gardener’s residence, a barn, tool house, well house, pergola, and a work shop (Marek 2011; Cox et al. 2001). Memorial markers, such as planted trees, a sun dial, and small stone monuments dot the landscape specifically near the northwestern end of the site (**Figure 2.5**). However, the most drastic modifications to the landscape are likely those associated with the construction of the San Jacinto monument and the reflecting pool (**Figure 2.6**), as well as the berth excavated for Battleship Texas.

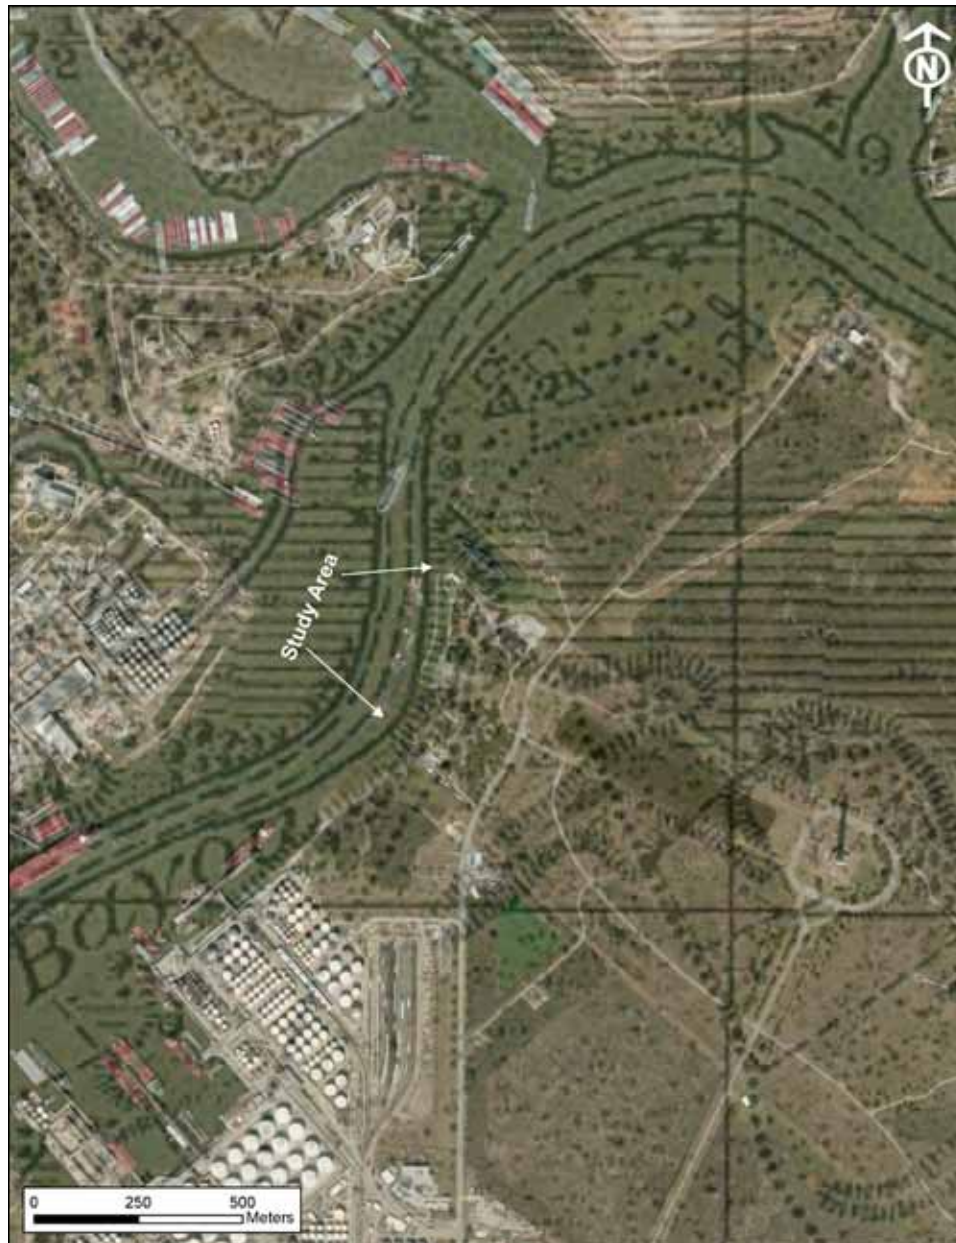
Figure 4.1. Overlay of the 1916 USGS topographical map onto 2010 aerial basemap.

Nonetheless, several pre-1916 cartographic sources have been useful in evaluating changes in shoreline. The 1905 Corps of Engineers (COE) Map of Galveston Bay and the 1916 Corps of Engineers Topographical Map of Burnett Bay do offer very accurate depictions of Buffalo Bayou, its meanders, and the shoreline at San Jacinto. Overlay of those maps onto modern aerial photographs show how radically the landscape around San Jacinto has changed since the beginning of the twentieth century (**Figure 4.1**).

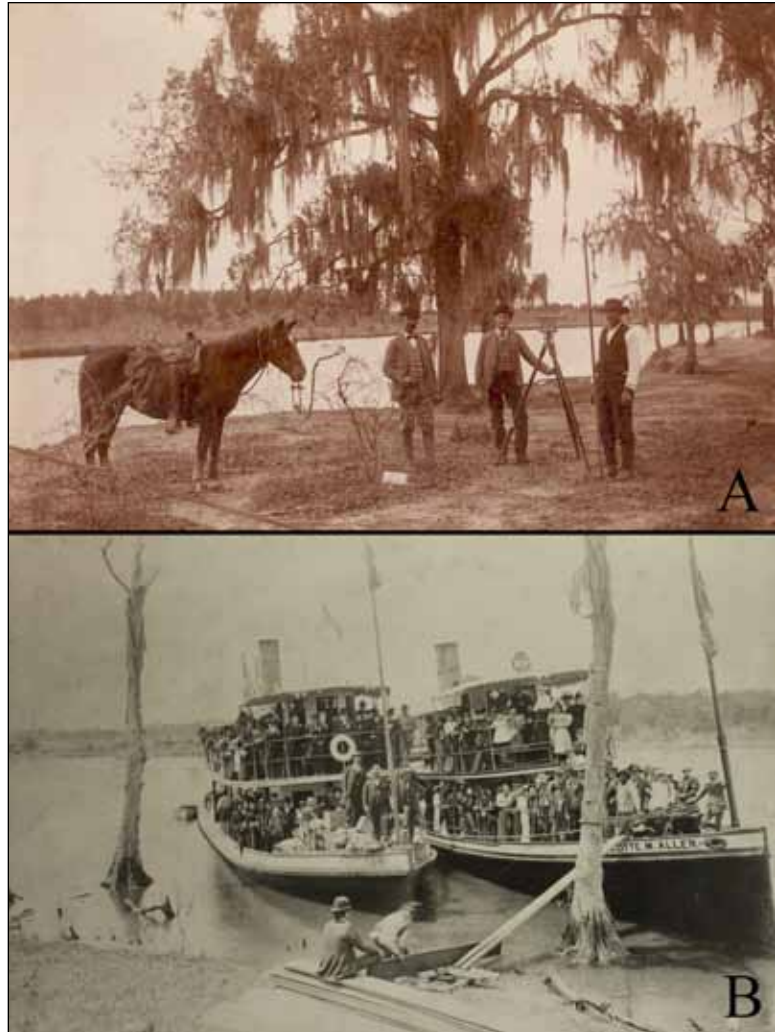
Figure 4.4. Two views of Buffalo Bayou near the battleground: A) 1893 photo of men surveying the banks of Buffalo Bayou; B) Steamboats bringing veterans and visitors to the battleground in 1894.

Early photographs of the shoreline at the San Jacinto Battleground help confirm that the bayou banks were little altered until 1914. An 1893 photograph of Buffalo Bayou near the Texan camp depicts a steep bank along Buffalo Bayou above the water level (**Figure 4.4A**). The height

of the bank above the water line is unclear, though it appears to be at least six feet. The 1916 topographical map also depicts a steep bank at the Texan camp and indicates that the camp area was between 10 and 15 feet above mean sea level. At the time that the 1893 photograph was taken, there were no landscape alterations along the shore. Another photograph—taken during the 1894 veteran’s visit to the battleground—depicts a marshy landing with no landscape infrastructure along the bank (**Figure 4.4B**).

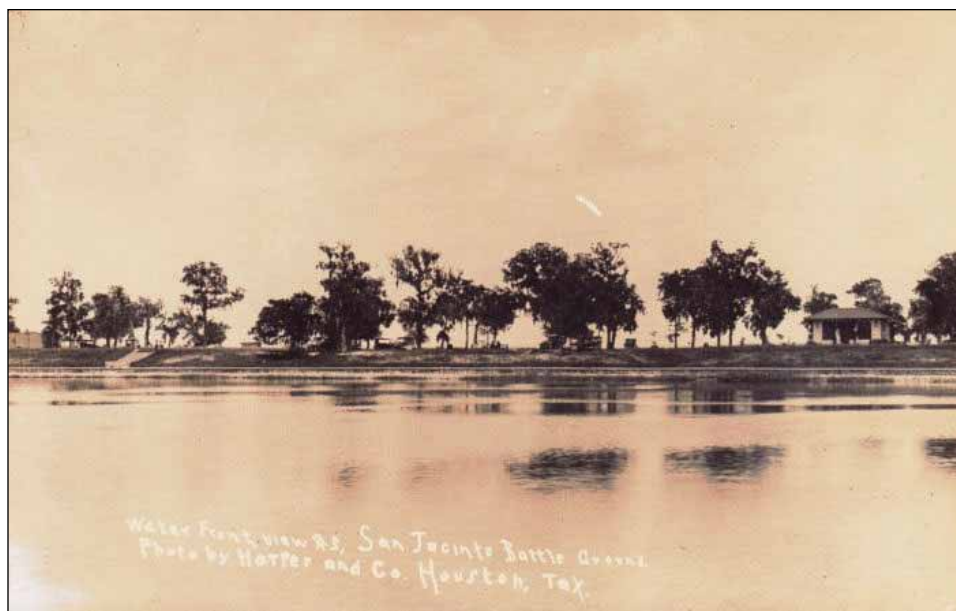
Figure 4.5. Undated photograph of the Buffalo Bayou shoreline at the San Jacinto site. The photograph shows the northernmost of the two concrete staircases and the boardwalk (or possibly a bulkhead) along the shoreline. This boardwalk extended down to the southern staircase and ferry landing which lead to a flagpole at the top of the bank.

from the 19-teens (see Figures 4.5, 4.6 and 4.12A) and an aerial photograph from 1930 (see Figure 4.10). This was built of concrete to match the boat docks and staircases leading from the water's edge up to the site (DeVault 1999). These early interventions likely did much to preserve the shoreline along the Texan camp area of the San Jacinto Battlefield State Historic Site.

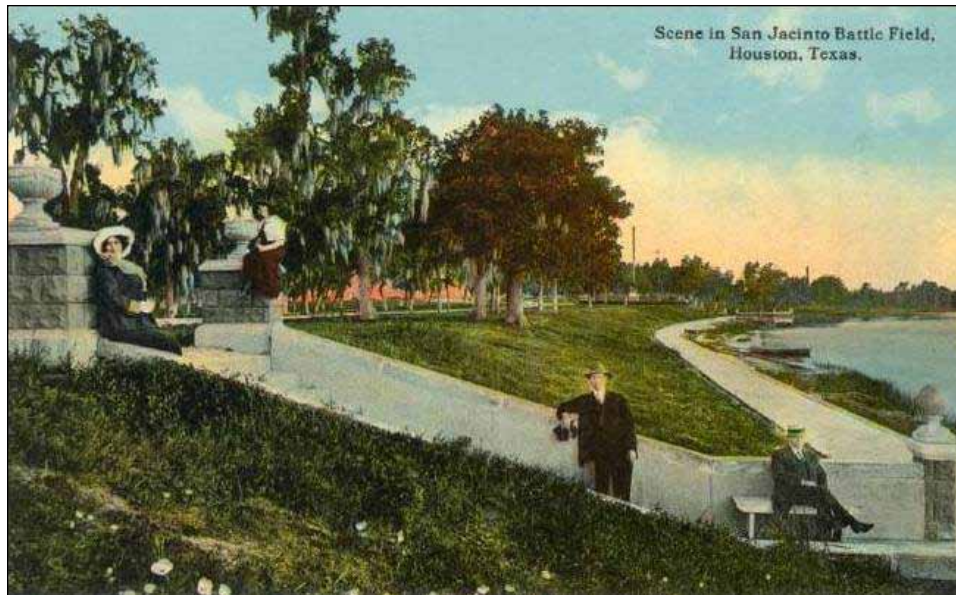
Figure 4.6. Undated early twentieth century postcard of the concrete ferry landing. Note the built improvements and grading along the shoreline. View is looking south.

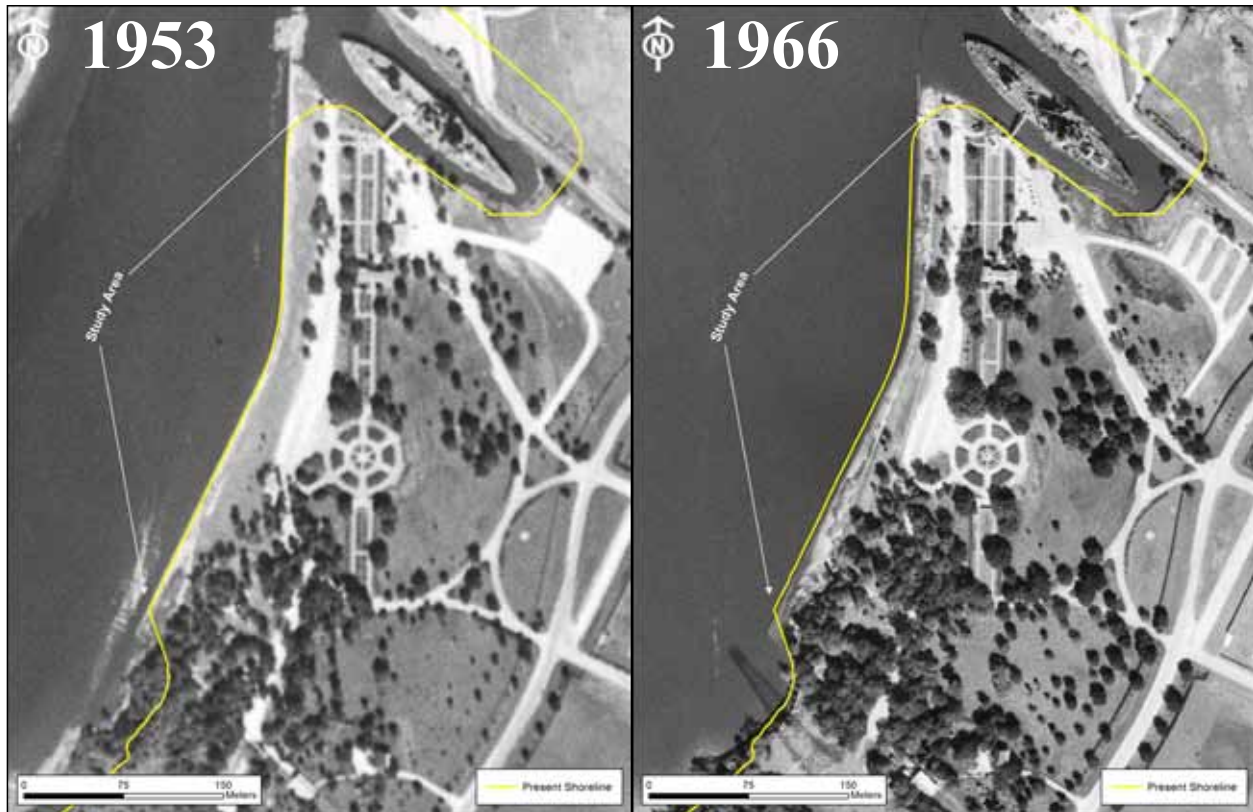
Figure 4.13. Comparison of 1953 and 1966 aerial photographs showing erosion along 1936 bulkhead.

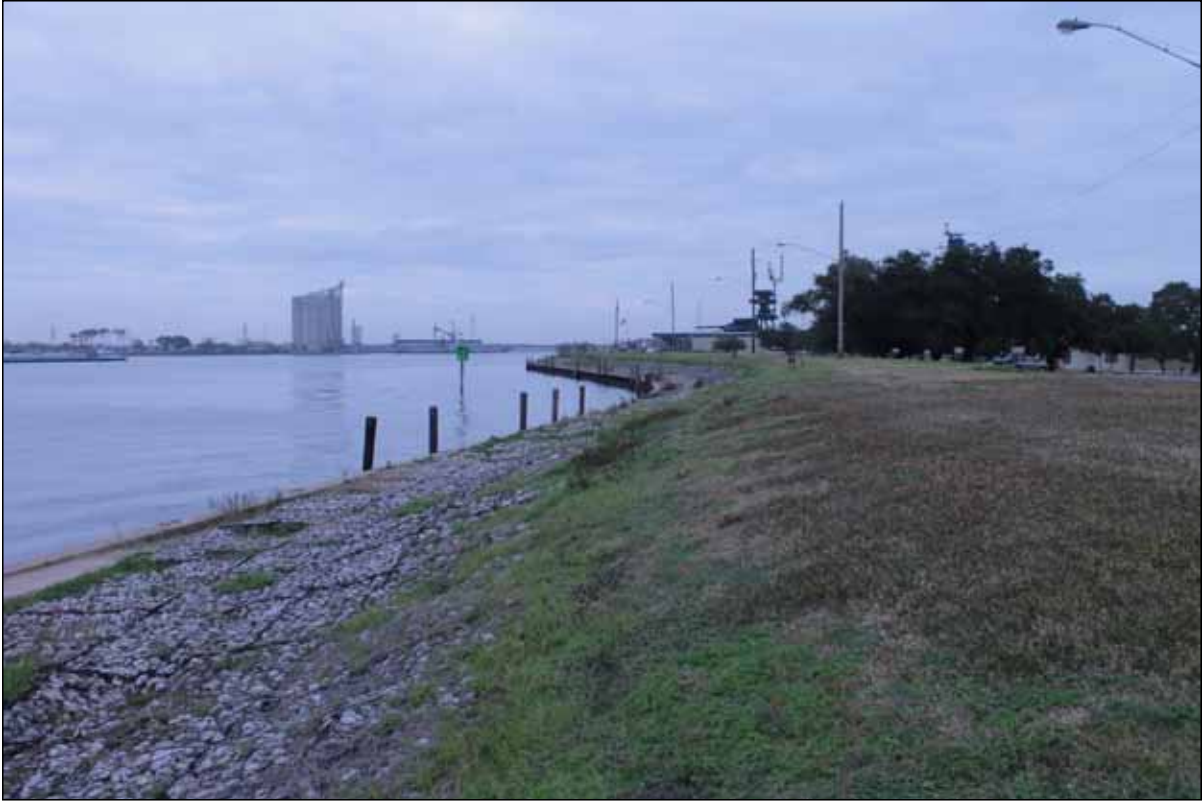
Figure 4.15. Photograph taken 2014 showing shoreline bulkhead and shoreline along Buffalo Bayou. Compare view to photos in Figure 4.11.
